W3150A+/W5100 Errata Sheet

Document History

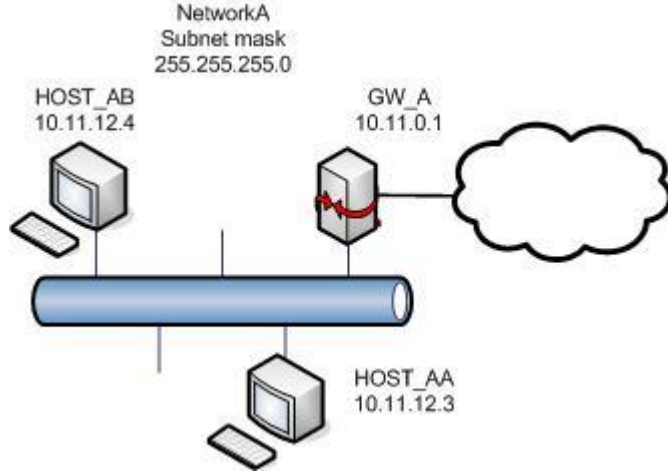
Erratum 1	
Phenomenon	<p>Unable to complete SEND/SENDMAC command in UDP/IP-Raw mode. That is, do not assert SEND_OK interrupt and do not equal the values of Socket n Tx Read Pointer Register (Sn_TX_RD) and Socket n Tx Write Pointer Register (Sn_TX_WR).</p>
Condition	<p>Generally, the Sn_TX_RD value is equal to the Sn_TX_WR value and asserts SEND_OK interrupt when a transmission process was completed. But the case of errata which the Sn_TX_RD and Sn_TX_WR values are different and do not assert SEND_OK interrupt in UDP/IP-Raw mode. This phenomenon is occurred when our chip receive data in opened socket (i.e. assert RECV interrupt) and simultaneously the application program (Host MCU) executes SEND/SENDMAC command on that socket.</p> <div style="text-align: center;">

<p>Figure 1. General network</p> </div> <p>In Figure 1 network,</p> <ol style="list-style-type: none"> 1. Open UDP socket in AA. Port number is 1000. 2. Send UDP data packet(destination port number 1000) from AB to AA. 3. AA processes the UDP data packet from AB. 4. Host MCU in AA runs SEND command to send. <p>When completion of 3 in AA (i.e. AA assert RECV interrupt), AA also runs 4 (i.e. run SEND command). In that case, do not complete process 4 due to errata.</p>

Solution	<p>In case of W3150A+,</p> <p>If you can monitor the RXDV signal (in MII interface), you can solve this problem.</p> <p>Before you execute SEND/SENDMAC command in UDP/IP-Raw mode, check the value of RXDV signal is '0'. That means there is no received data packet, so you can avoid the errata condition.</p> <p>Refer to following pseudo-code.</p> <pre style="background-color: #f0f0f0; padding: 10px;"> /* Change sendto() function */ Function sendto() { ... While (RXDV == '1') ; SEND command; /* Complete Sending */ } </pre>
Recommendation	<p>In case of W5100,</p> <p>We don't have solution but we can give a recommendation.</p> <p>After complete a transmission process, check whether Sn_TX_RD and Sn_TX_WR have same values or not. If both values are still different, close the socket and reset by force.</p> <pre style="background-color: #f0f0f0; padding: 10px;"> /* Change sendto() function */ Function sendto() { ... /* Complete Sending */ /* wait until Sn_TX_WR and Sn_TX_RD are same */ While (Sn_TX_WR != Sn_TX_RD) { wait some time; loop_cnt++; if (loop_cnt > CONST_BLOCK_CNT) goto RESET } } </pre>

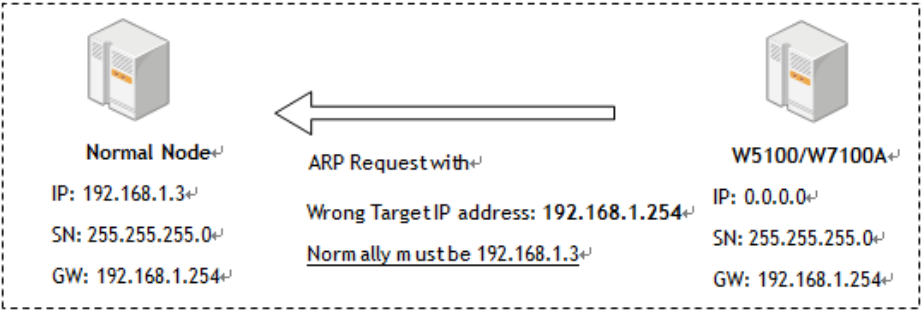
Erratum 3	
Phenomenon	Assuming that the IP address of W5100 is “0.0.0.0” and the gateway, subnet mask is valid (not “0.0.0.0”), the W5100 set the target IP address of ARP request to the gateway IP address not the target node IP address when sends ARP request to another node. So the peer node cannot receive the ARP request from the W5100.
Condition	<div style="border: 1px dashed black; padding: 10px; text-align: center;">

<p>Normal Node IP: 192.168.1.3 SN: 255.255.255.0 GW: 192.168.1.254</p> <p>W5100/W7100A IP: 0.0.0.0 SN: 255.255.255.0 GW: 192.168.1.254</p> <p>ARP Request with Wrong Target IP address: 192.168.1.254 <u>Normally must be 192.168.1.3</u></p> </div> <p>The W5100 miss calculates the sub-network location when sends the ARP request if its own IP address is “0.0.0.0”. In the same condition, even if the gateway IP address is “0.0.0.0”, the W5100 sends ARP request to “0.0.0.0” IP address because the W5100 sends ARP request to the gateway.</p>

Solution	The reason of this erratum3 is same as erratum2 so the solution is also same with erratum2. Please refer to the solution of erratum2.
