W5300 Errata Sheet

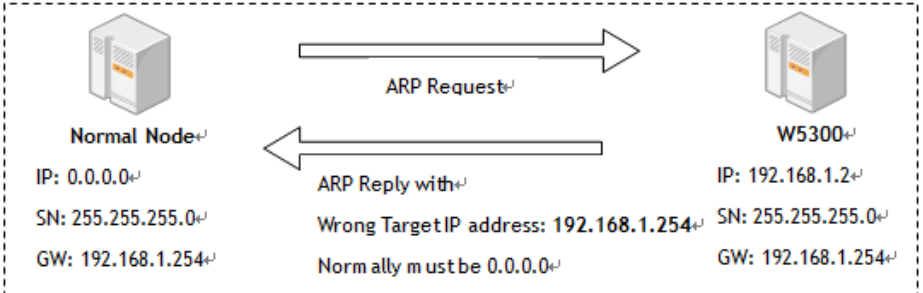
Erratum 4	
Phenomenon	The W5300 replies with gateway IP address for the ARP request from normal node which has “0.0.0.0” IP address. But normally the W5300 should replies with target IP address “0.0.0.0” not the gateway IP address.
Condition	<div style="border: 1px dashed black; padding: 10px; text-align: center;">

<p>Normal Node IP: 0.0.0.0 SN: 255.255.255.0 GW: 192.168.1.254</p> <p>W5300 IP: 192.168.1.2 SN: 255.255.255.0 GW: 192.168.1.254</p> <p>ARP Request</p> <p>ARP Reply with Wrong Target IP address: 192.168.1.254 Normally must be 0.0.0.0</p> </div> <p>The main reason of this erratum is subnet calculating logic. The W5300 misunderstands the node locates other sub-network when target has “0.0.0.0” IP address. So the W5300 set the target IP to the gateway IP instead of “0.0.0.0” and sends the ARP reply.</p>
Solution & Recommendation	<p>To avoid this erratum we must keep the subnet mask register value to zero except two cases which are “CONNECT” command in TCP and “SEND” command in UDP. Because only these two cases are referring the subnet mask register and sending the ARP request.</p> <p>So set the subnet mask register to “0.0.0.0” and keeping it but save the right subnet mask value to the global variable when you initialize the W5300. When you use connect command in TCP or send command in UDP, set the subnet mask register to the right value using the variable before executing connect or send command. After done connect or send command, clears the subnet mask register again to keep its value to “0.0.0.0”</p> <p>In the case of applying, you can’t use the subnet broadcasting.</p>

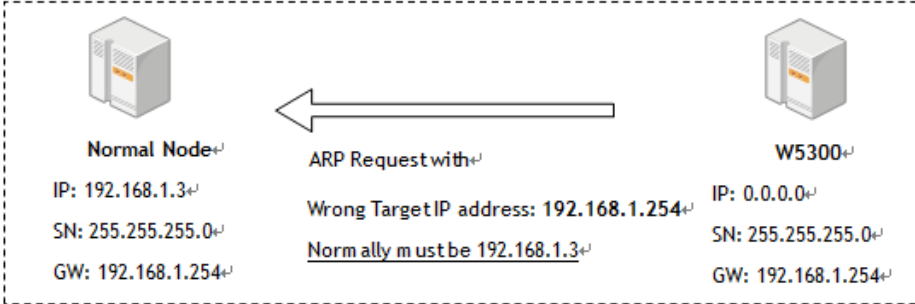
Erratum 5	
Phenomenon	Assuming that the IP address of W5300 is “0.0.0.0” and the gateway, subnet mask is valid (not “0.0.0.0”), the W5300 set the target IP address of ARP request to the gateway IP address not the target node IP address when sends ARP request to another node. So the peer node cannot receive the ARP request from the W5300.
Condition	<div style="border: 1px dashed black; padding: 10px; text-align: center;">

<p>Normal Node IP: 192.168.1.3 SN: 255.255.255.0 GW: 192.168.1.254</p> <p>W5300 IP: 0.0.0.0 SN: 255.255.255.0 GW: 192.168.1.254</p> </div> <p>The W5300 miss calculates the sub-network location when sends the ARP request if its own IP address is “0.0.0.0”. In the same condition, even if the gateway IP address is “0.0.0.0”, the W5300 sends ARP request to “0.0.0.0” IP address because the W5300 sends ARP request to the gateway.</p>
Solution & Recommendation	The reason of this erratum5 is same as erratum4 so the solution is also same with erratum4. Please refer to the solution of erratum4.
