W5300 Errata Sheet

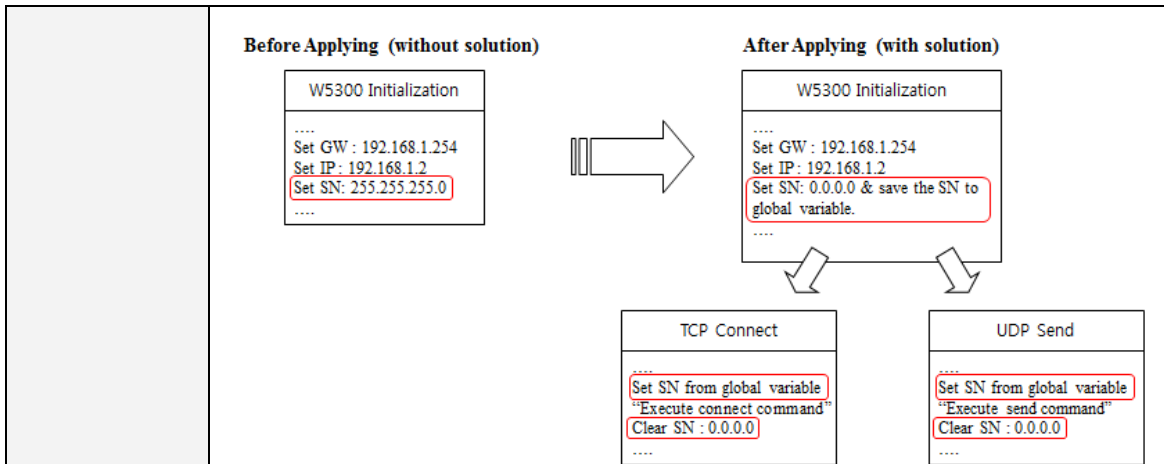
Erratum 4	
Phenomenon	The W5300 replies with gateway IP address for the ARP request from normal node which has “0.0.0.0” IP address. But normally the W5300 should replies with target IP address “0.0.0.0” not the gateway IP address.
Condition	<div style="border: 1px dashed black; padding: 10px; text-align: center;">

<p>Normal Node IP: 0.0.0.0 SN: 255.255.255.0 GW: 192.168.1.254</p> <p>W5300 IP: 192.168.1.2 SN: 255.255.255.0 GW: 192.168.1.254</p> <p>ARP Request</p> <p>ARP Reply with Wrong Target IP address: 192.168.1.254 Normally must be 0.0.0.0</p> </div> <p>The main reason of this erratum is subnet calculating logic. The W5300 misunderstands the node locates other sub-network when target has “0.0.0.0” IP address. So the W5300 set the target IP to the gateway IP instead of “0.0.0.0” and sends the ARP reply.</p>
Solution & Recommendation	<p>To avoid this erratum we must keep the subnet mask register value to zero except two cases which are “CONNECT” command in TCP and “SEND” command in UDP. Because only these two cases are referring the subnet mask register and sending the ARP request.</p> <p>So set the subnet mask register to “0.0.0.0” and keeping it but save the right subnet mask value to the global variable when you initialize the W5300. When you use connect command in TCP or send command in UDP, set the subnet mask register to the right value using the variable before executing connect or send command. After done connect or send command, clears the subnet mask register again to keep its value to “0.0.0.0”</p> <p>In the case of applying, you can’t use the subnet broadcasting.</p>

Example pseudo code:
